Manhole Inspection Summary

Manhole # S33I__005MH

Inspection ☐ Is Incomplete Rating: **2) Good**

Insp Date: **11/12/08 2:48 PM**

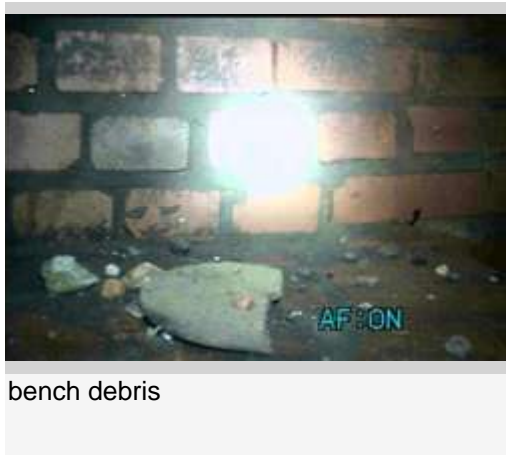
Defect 2

Condition: ☐ Sound ☐ Cracked ☐ Root Intrusion ☐ Deteriorated ☐ Leaks ☒ **Debris**

bench debris

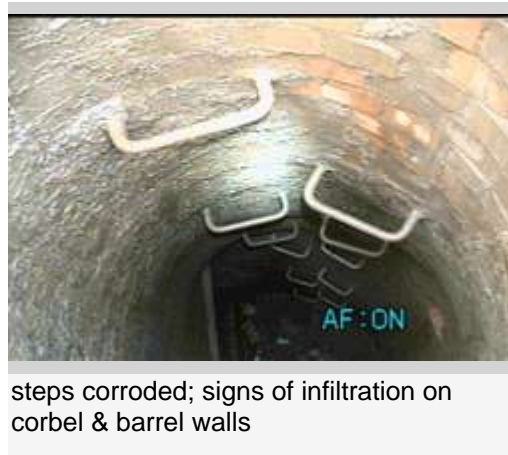
Defect 1

Infiltration: ☐ None ☐ Joint ☐ Cracks ☐ Mortar ☐ Roots ☒ **Wall**

Count: **11** Missing: **0** ☒ **Corroded**

steps corroded; signs of infiltration on corbel & barrel walls

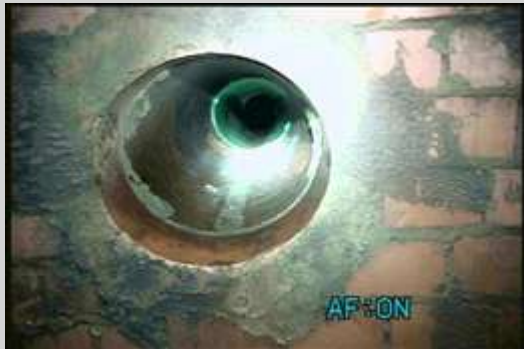
9 O'Clock Inflow

has a pvc insert

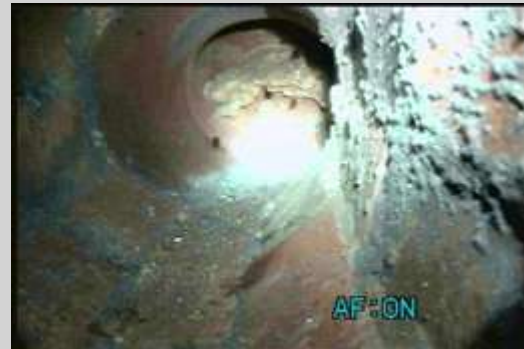
Drop In @ 9 O'Clock

Drop: **Outside** **Direct**

Drop Condition: **Clogged**
